# *Upgrading of Existing Structures*

## *Phase III*

### *Shelter Design Options*

**FINAL REPORT**

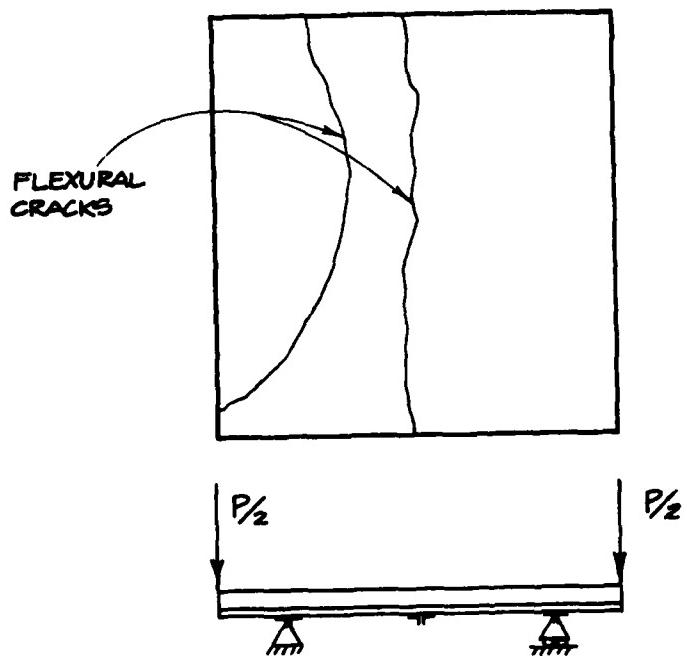
Fig. 2-40. Sketch Showing Location of Flexural Cracks,  
Test No. 80-4B.

Failure occurred as expected with flexural cracks in the top tension fibers of the section in the region of maximum moment (ie., between supports). See Figure 2-40 for crack location.

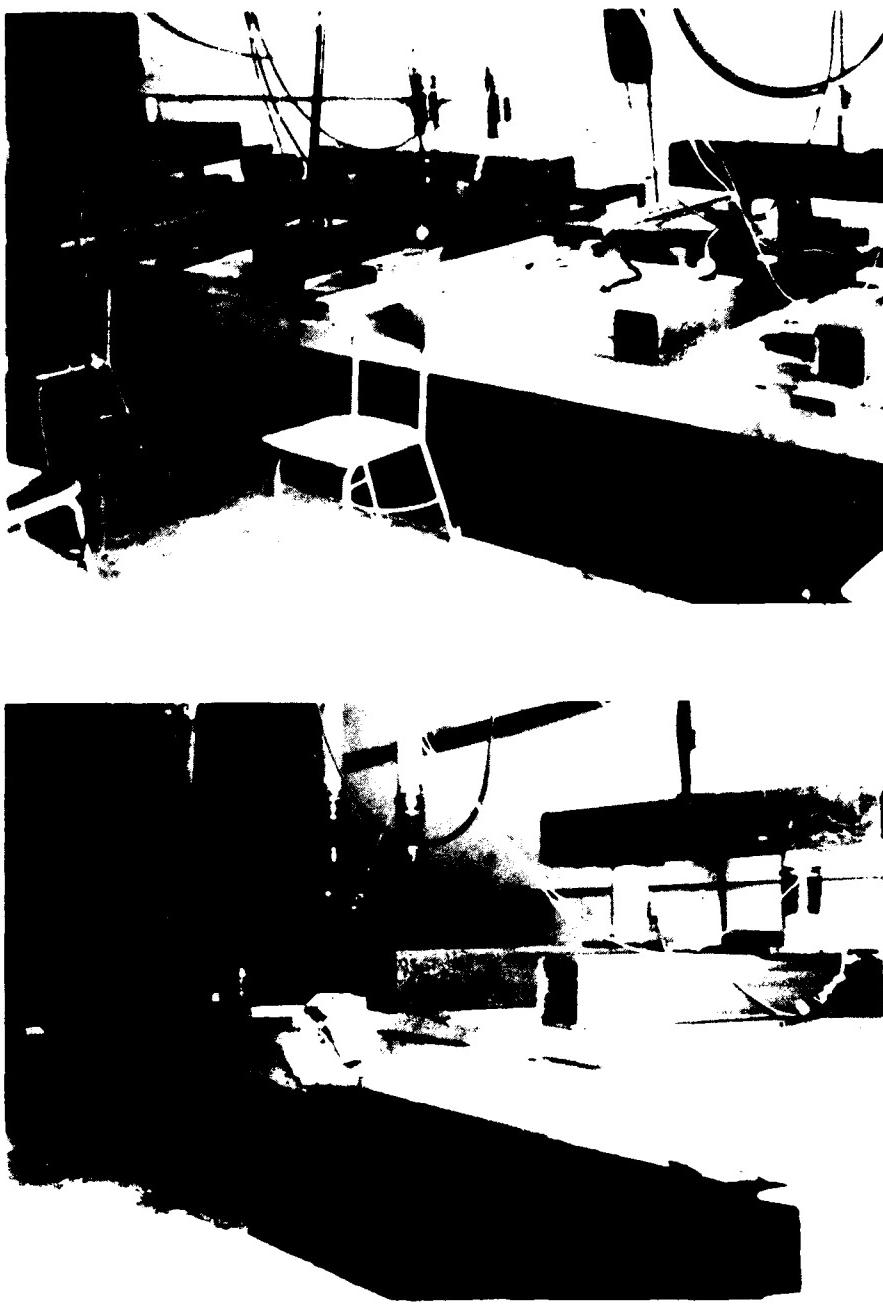
Positive moment tension cracks first occurred at the center of the spans at 2,669 psf (18.5 psi), and the first negative moment tension crack occurred over a shore at 4,004 psf (27.8 psi). The slab failed when bond failure of the prestressing strands occurred at the slab ends, resulting in a shear/flexure failure near the end supports. The center span continued to be loaded until failure, which occurred at 7,474 psf (51.9 psi) and was the result of a shear/flexure failure adjacent to the right shore.

Figure 3-55 shows the slab before and after test. Figure 3-56 shows the failure near the left and right supports. Figure 3-57A shows the negative moment tension crack over the left shore after test, and Figure 3-57B shows the failure adjacent to the right shore after test.

Fig. 3-55. Pre- and Posttest Photographs, Test No. 13.

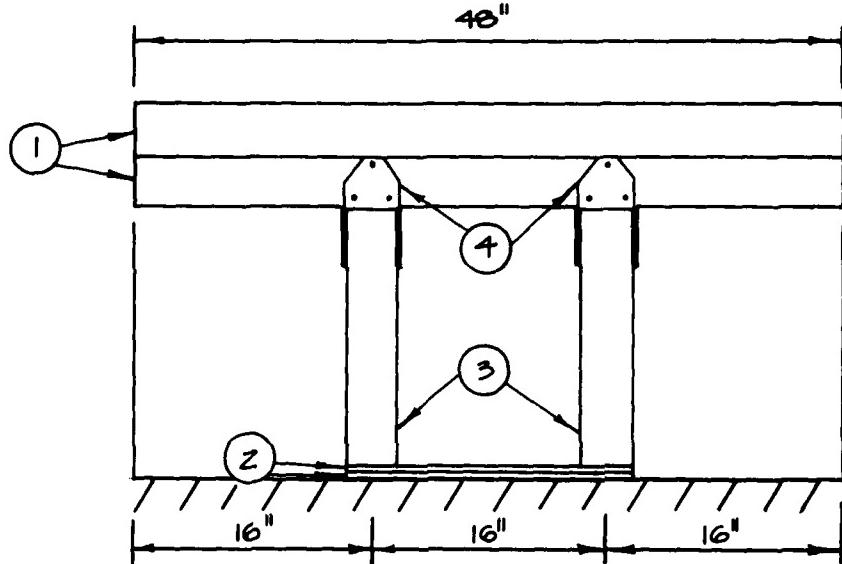
Fig. 4-16. Shores Used at One-Third Span, Assembly No. 16.

The assembly in this test was again simply supported at its ends. The shores were located at the one-third points of the span. Both shores were constructed as shown in Figure 4-16 and were shimmed tightly against the bottom of the joists. [Note: The shore detail differs from the single shore test (No. 15) in that metal post caps were used.] The load was applied at six locations by hydraulic rams in the configuration shown in Figure 4-17. The vertical deflections were measured and recorded at the center of each of the three spans, over both shores, and over each end support. The moisture content of the joists was measured at 10.0%.

- ① 4" x 4" x 4'
- ②  $\frac{1}{2}$ " x 12" x 14" PLYWOOD
- ③ 4" x 4" x 17 $\frac{1}{2}$ "
- ④ 4" x 4" POST CAP/BASE CONNECTORS,  
18 GAUGE GALVANIZED STEEL

4" x 4" x 4' ARE NAILED TOGETHER WITH FOUR 8d COMMON NAILS (TOENAILED).

THE PLYWOOD WAS NOT NAILED.

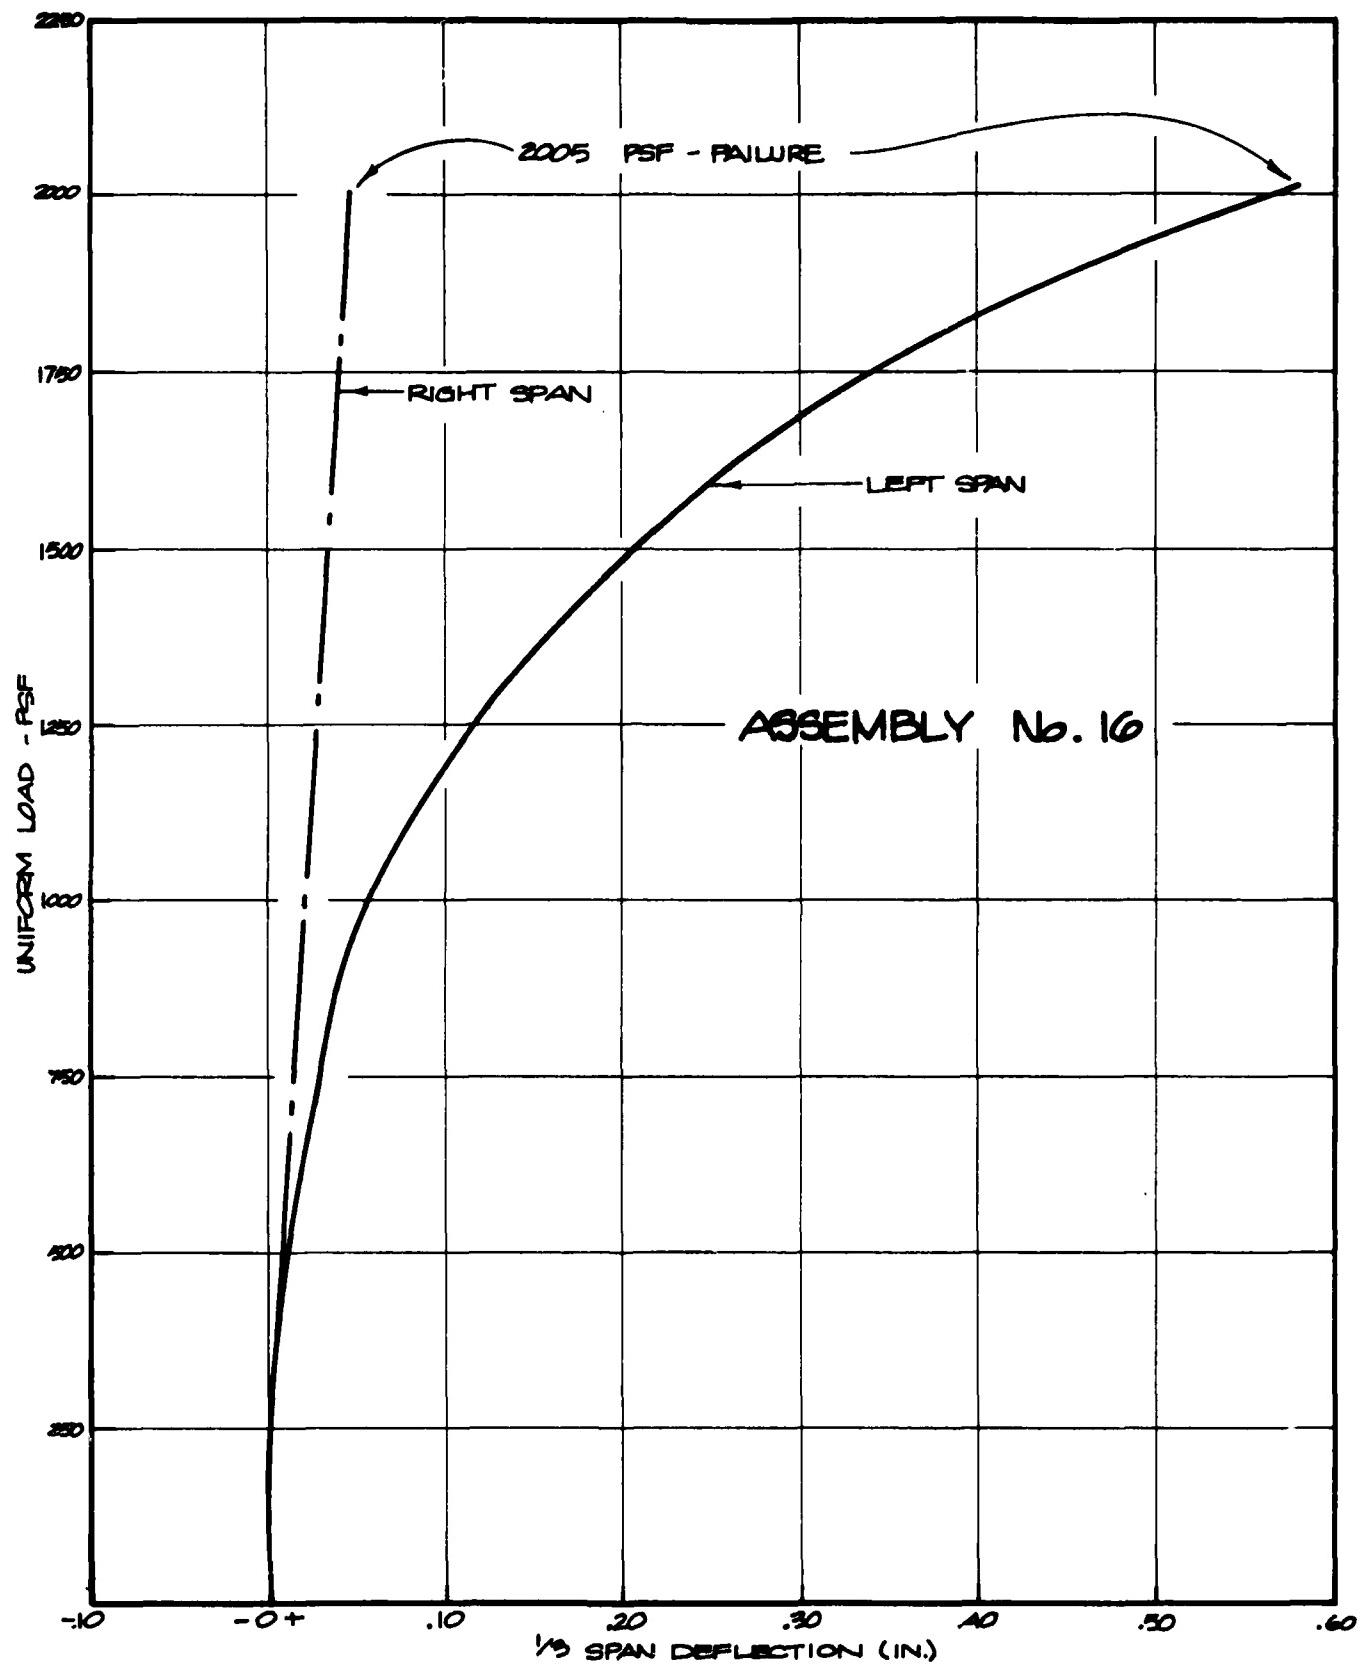
Fig. 4-18. Uniform Load vs Deflection, Assembly No. 16.

The assembly failed with each ram applying a load of 32,000 lb. The calculated uniform load at failure was 2,005 psf (13.9 psi). The relative deflections, as measured immediately prior to the failure, were 0.59 inches at the center of the left span and 0.05 inches at the center of the right span. The uniform load vs deflection curve for this test is shown in Figure 4-18.

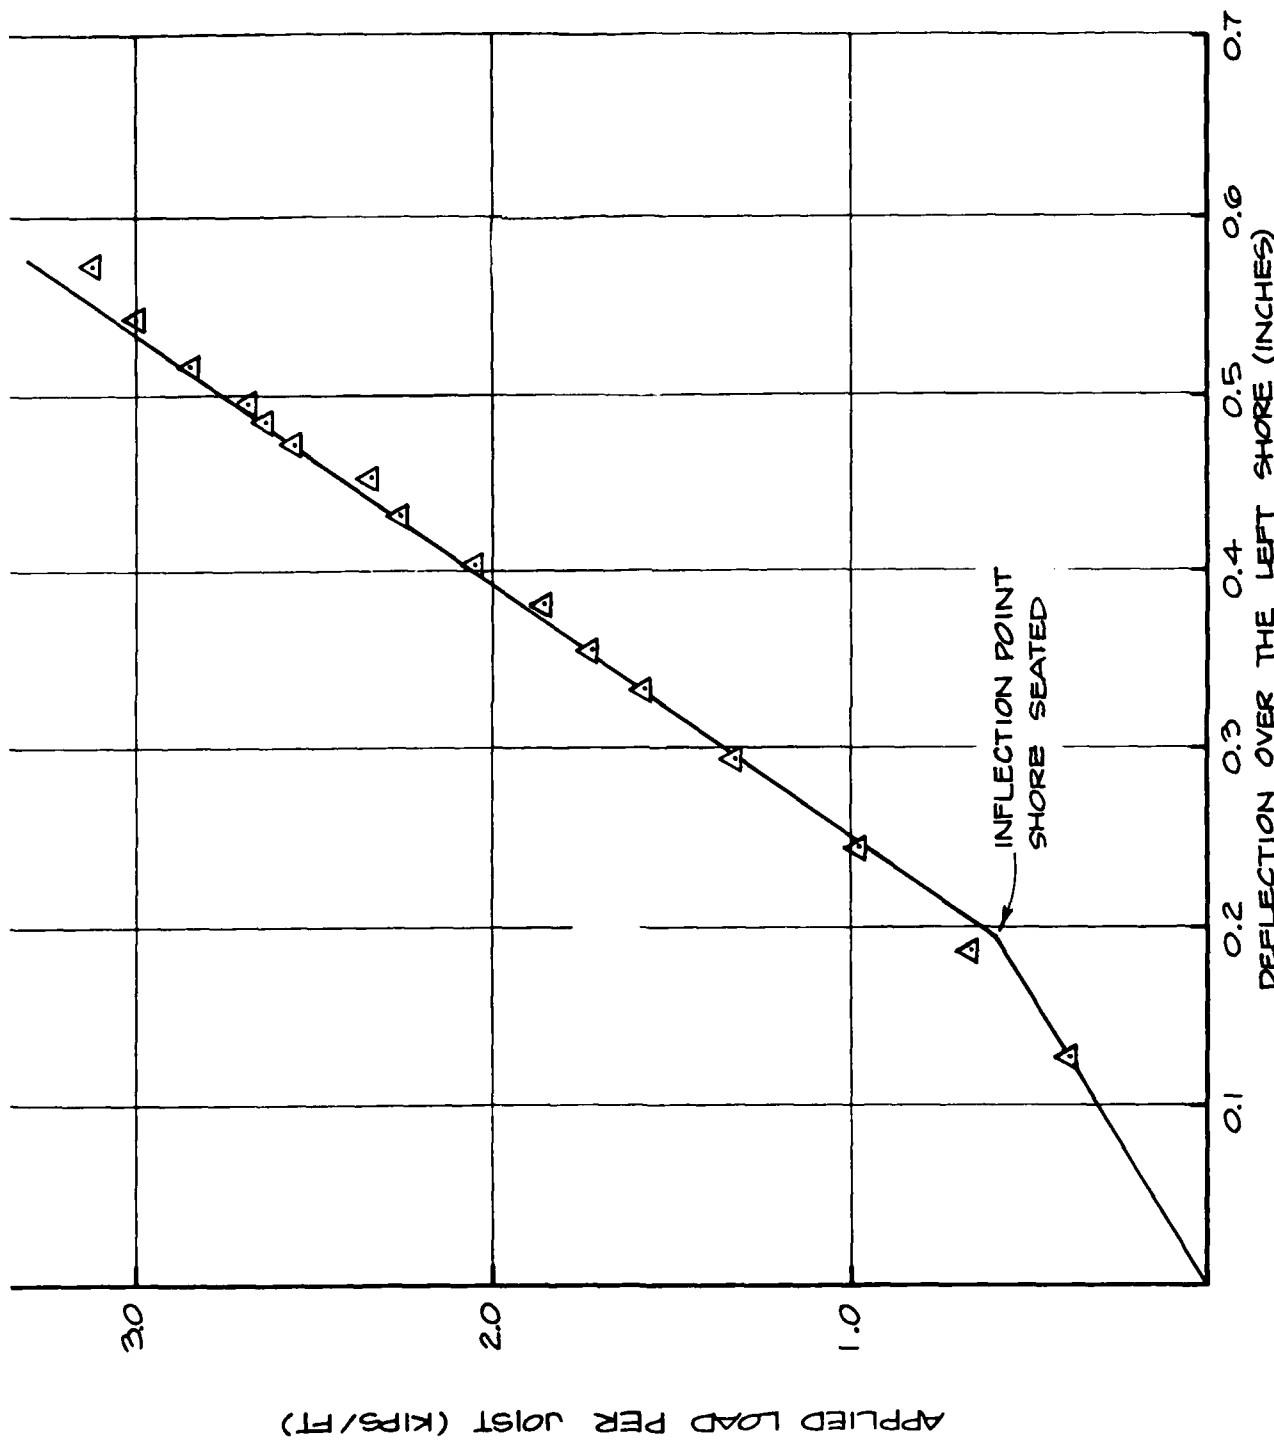
Fig. A-3. Load vs Deflection, Test No. 79-2.

Failure is predicted at a load of 3,300 plf/joist. Floor Test No. 79-2 failed in one or both of the following modes:

- 1) The left shore failed due to combined bearing and shear failure in the wood beam supporting the floor.
- 2) The top chord failed in flexure as a result of web member ⑩ yielding in tension leading to a redistribution of the load.

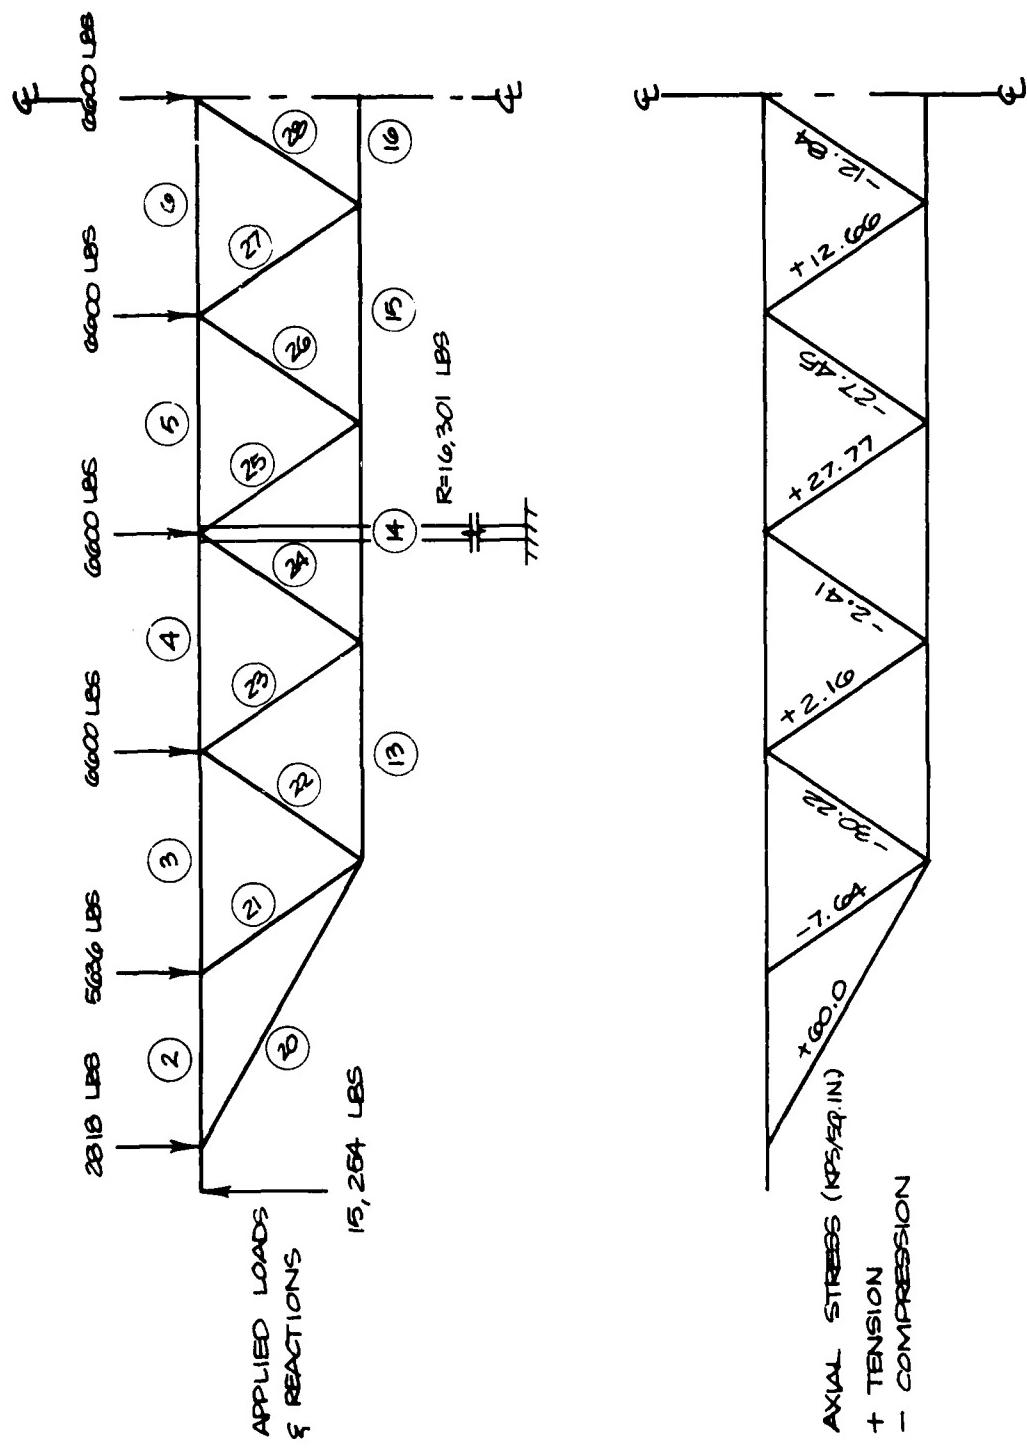
Fig. A-4. Computer Model Analysis Results for a Double Shored, 18H8 Open-Web Steel Joist.  
(Ultimate Failure Load,  $w_u = 3,300 \text{ psf/joist}$ ).

The analysis indicates a tensile stress of 60,000 psi in web member ⑩ at failure, exceeding the yield stress of 50,000 psi, but less than the ultimate stress of 76,000 psi.

In Figure A-4 the predicted axial stress for each of the web members is shown. The analysis predicts failure at 3,300 plf; in Test No. 79-2 the failure load was 3,920 plf; the prediction is 84% of the test value.

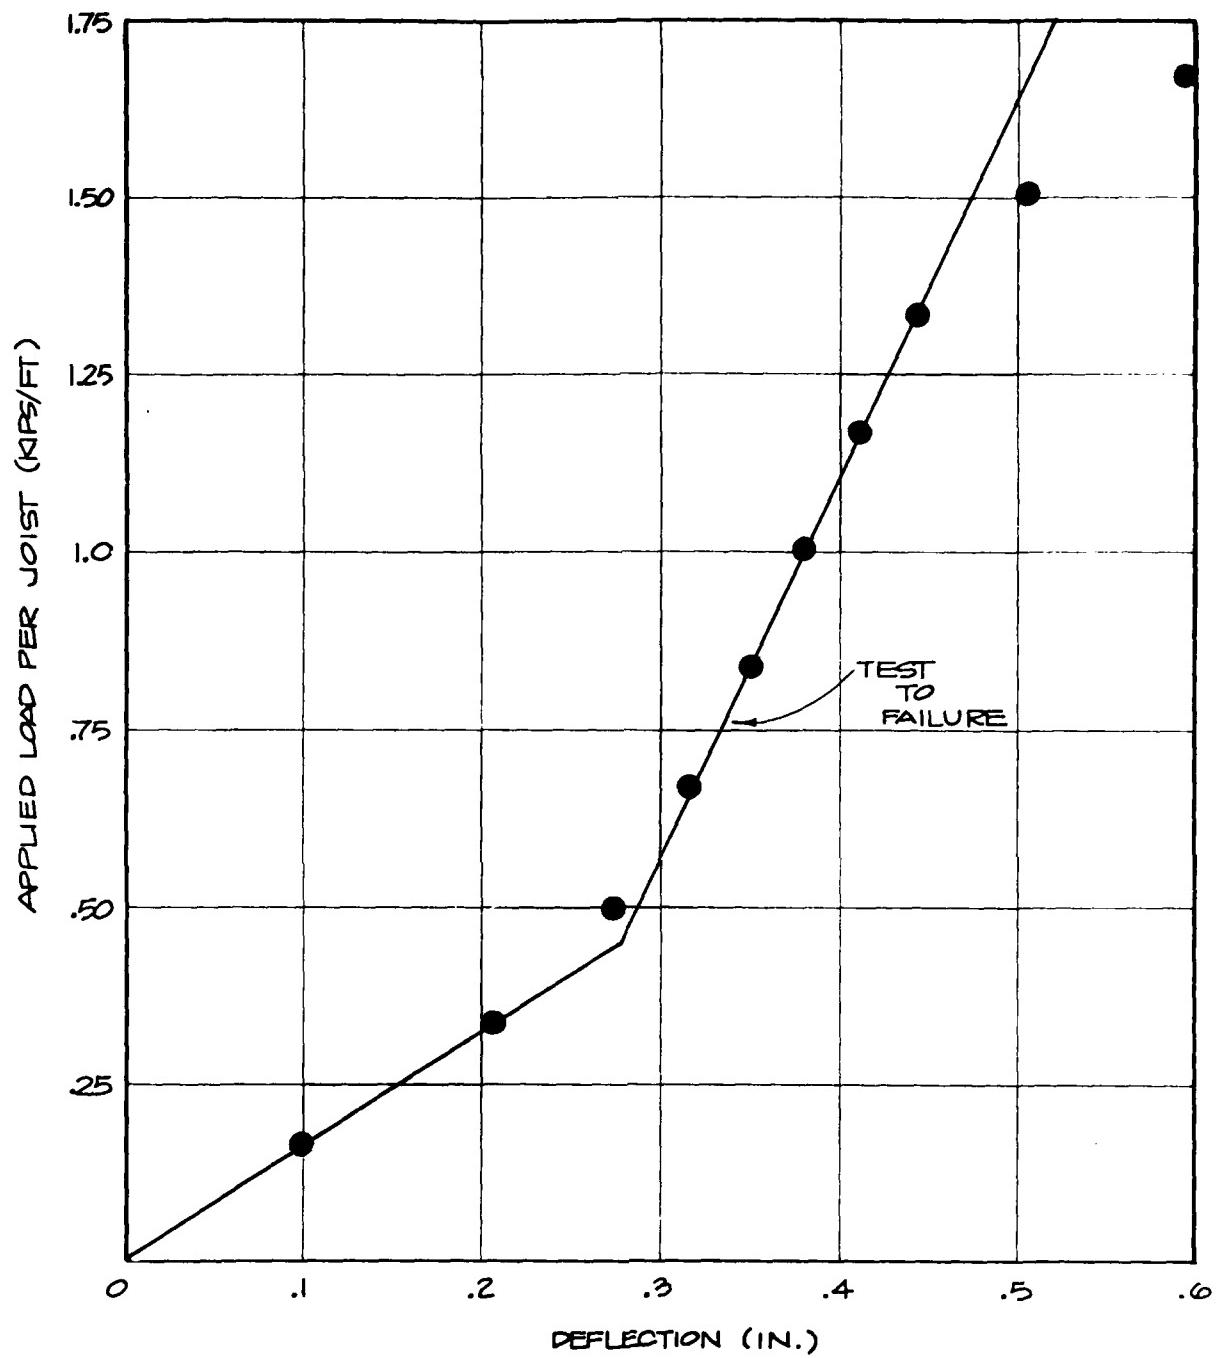
Fig. A-5. Load vs Deflection, Test No. 79-3.

The prediction indicates a floor failure at 1,750 plf/joist. Analysis predicts web members ②2 and ②0 to be critical. Figure A-6 shows the predicted axial stresses for the web members. Web member ②2 is at the calculated ultimate buckling stress and web member ②0 is at the calculated maximum yield stress in tension.

The prediction of 1,750 plf was 9% below the actual failure load of 1,928 plf.
